**Flood Control Project Maintenance  
Levee Inspections**

**Fall 2013 Levee Maintenance Deficiency Summary Report**

**San Joaquin River Basin**

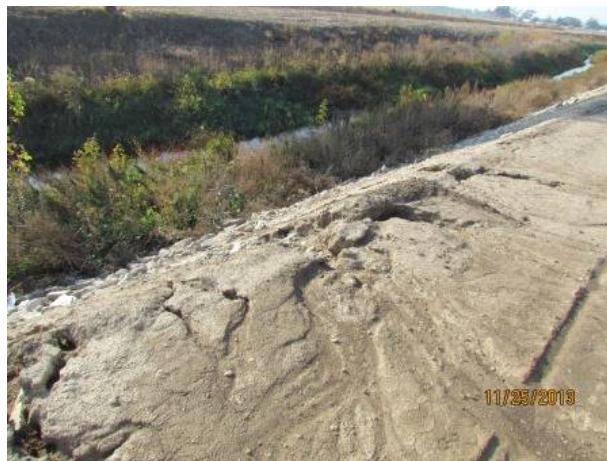
Levee Mile Report Line	9
Start Levee Mile	2.66
End Levee Mile	2.66
Location	Water Side
Category	Earthen Levee
Item	Encroachments
A pipe was found without a flap gate on waterside slope of the levee looking downstream. This pipe may predate the project.	
pkazi_f_20131001_012.JPG

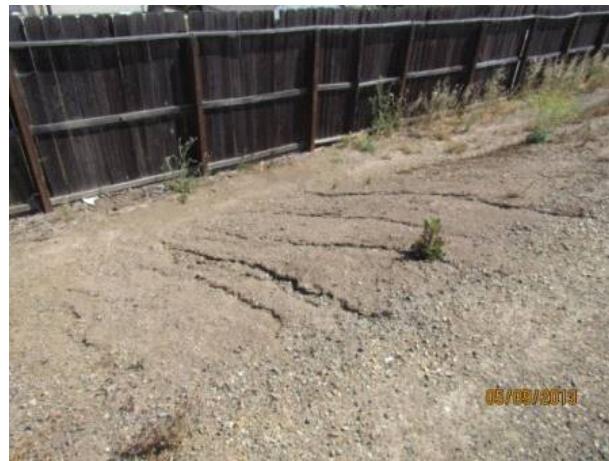
Levee Mile Report Line	3
Start Levee Mile	1.17
End Levee Mile	1.17
Location	Land Side
Category	Earthen Levee
Item	Erosion / Bank Caving
Runoff was discovered on the landside slope of the levee looking upstream.	
pkazi_f_20131019_938.JPG

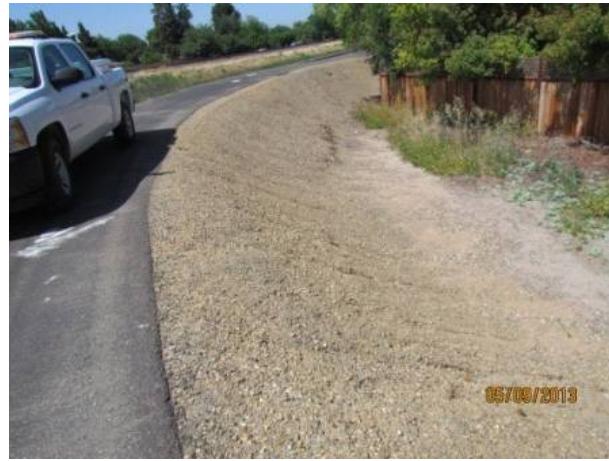
Levee Mile Report Line	9
Start Levee Mile	2.03
End Levee Mile	2.03
Location	Land Side
Category	Earthen Levee
Item	Erosion / Bank Caving
Runoff was found on the landside of the levee looking upstream.	
pkazi_f_20131019_941.JPG

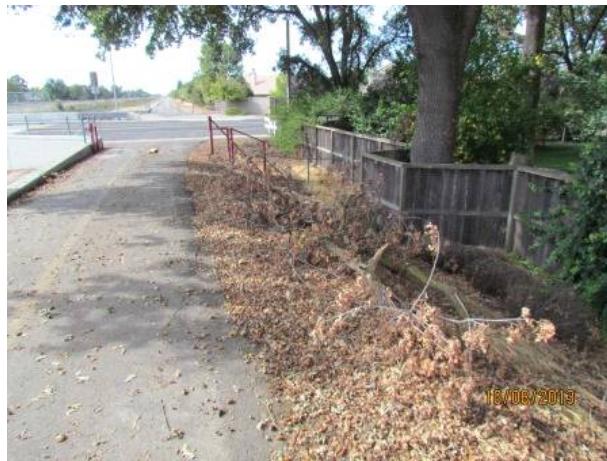
Levee Mile Report Line	17
Start Levee Mile	2.57
End Levee Mile	2.65
Location	Land Side
Category	Earthen Levee
Item	Encroachments
View of a wood fence adjacent to the landward toe looking upstream.	
pkazi_f_20131001_082.jpg

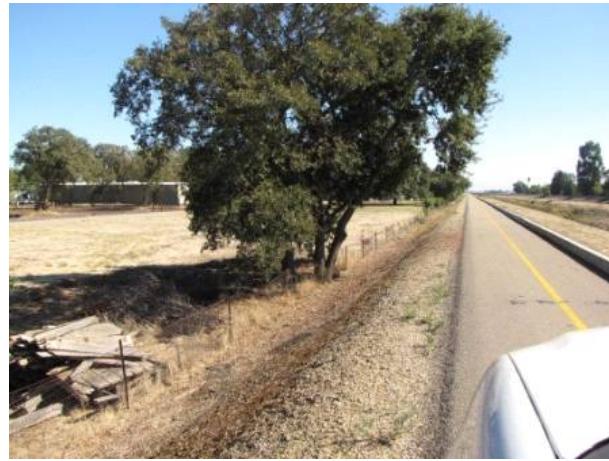
Levee Mile Report Line	21
Start Levee Mile	2.84
End Levee Mile	3.13
Location	Land Side
Category	Earthen Levee
Item	Encroachments
Fences were found on the landside toe of the levee looking upstream.	
pkazi_f_20131001_024.JPG

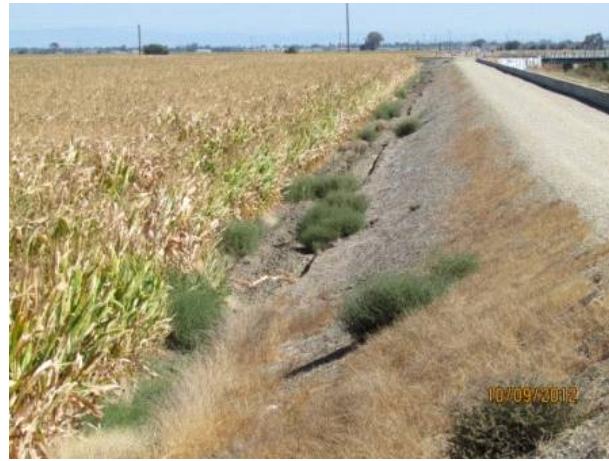
Levee Mile Report Line	24
Start Levee Mile	3.49
End Levee Mile	3.49
Location	Land Side
Category	Earthen Levee
Item	Animal Control
An animal hole was found on the landside of the levee looking upstream.	
pkazi_f_20131019_946.JPG

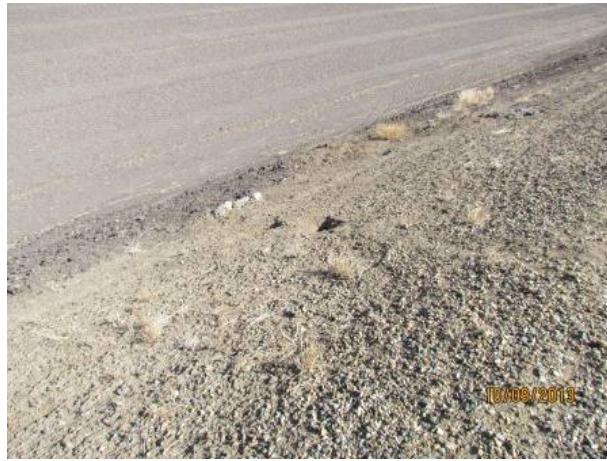
Levee Mile Report Line	27
Start Levee Mile	3.78
End Levee Mile	3.78
Location	Land Side
Category	Earthen Levee
Item	Erosion / Bank Caving
Erosion occurred due to runoff on the landside slope of the levee looking upstream.	
pkazi_f_20131019_949.JPG

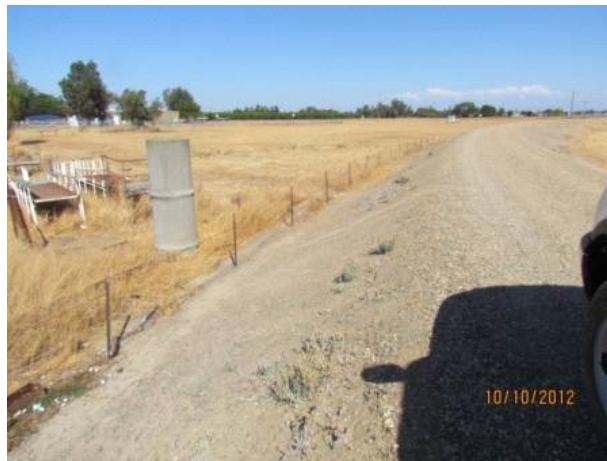
Levee Mile Report Line	67
Start Levee Mile	12.41
End Levee Mile	13.22
Location	Land Side
Category	Earthen Levee
Item	Encroachments
Fences were found on the landside toe of the levee looking upstream.	
pkazi_f_20131001_070.JPG

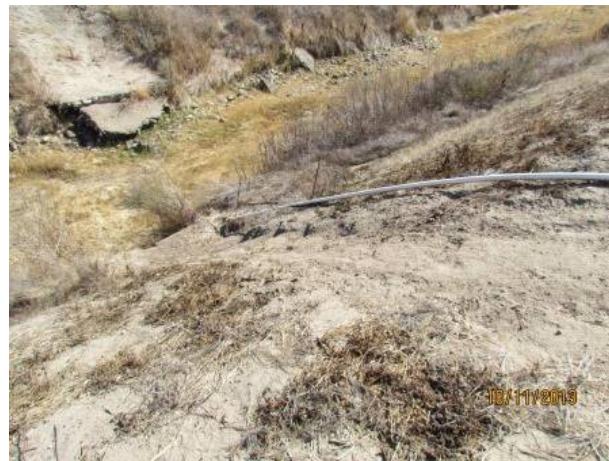
Levee Mile Report Line	82
Start Levee Mile	14.77
End Levee Mile	14.77
Location	Water Side
Category	Earthen Levee
Item	Encroachments
View of a pipe a landowner placed in the access road and waterward slope to pump water from the channel to irrigate their garden.	
pkazi_f_20131001_085.jpg

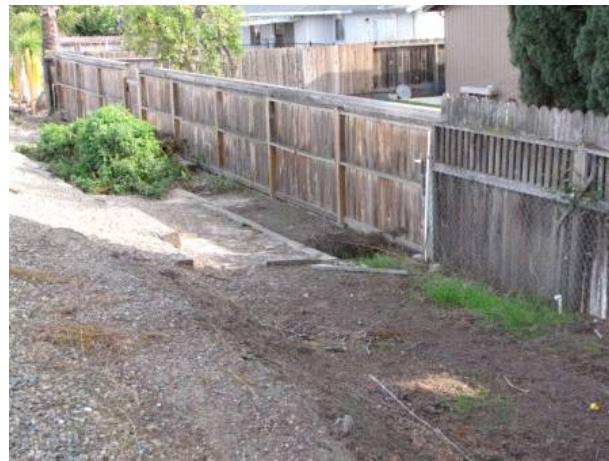
Levee Mile Report Line	72
Start Levee Mile	2.47
End Levee Mile	2.47
Location	Land Side
Category	Earthen Levee
Item	Vegetation
Landscaping was found on the landside toe of the levee looking upstream.	
pkazi_f_20131028_008.JPG

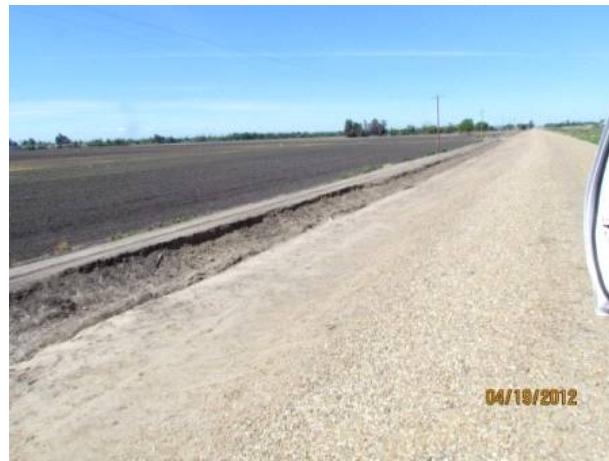
Levee Mile Report Line	96
Start Levee Mile	4.34
End Levee Mile	4.34
Location	Land Side
Category	Earthen Levee
Item	Erosion / Bank Caving
Runoff damage was found on the landside of the levee looking upstream.	
pkazi_f_20131026_003.JPG

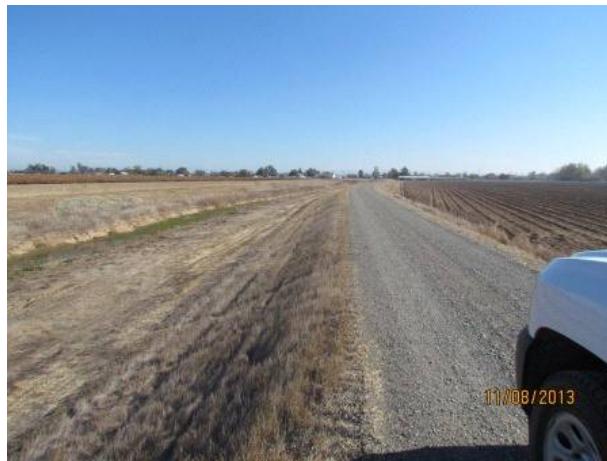
Levee Mile Report Line	4
Start Levee Mile	1.20
End Levee Mile	1.44
Location	Land Side
Category	Earthen Levee
Item	Encroachments
Fence was found on the landside toe of the levee looking upstream.	
pkazi_f_20131001_204.jpg

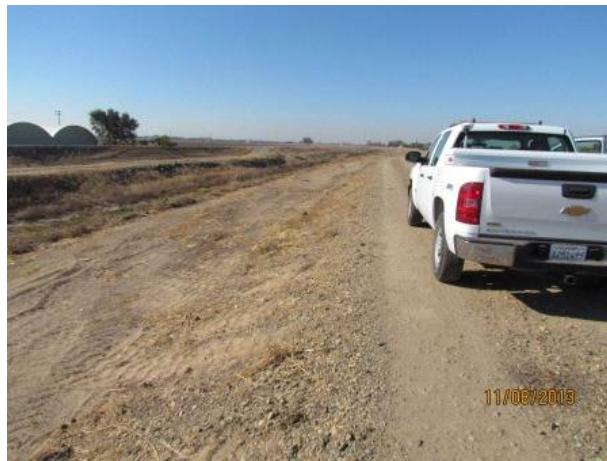
Levee Mile Report Line	3
Start Levee Mile	0.42
End Levee Mile	0.42
Location	Water Side
Category	Earthen Levee
Item	Encroachments
Pipe penetration was found under the crown of the levee looking downstream.	pkazi_f_20131001_211.jpg

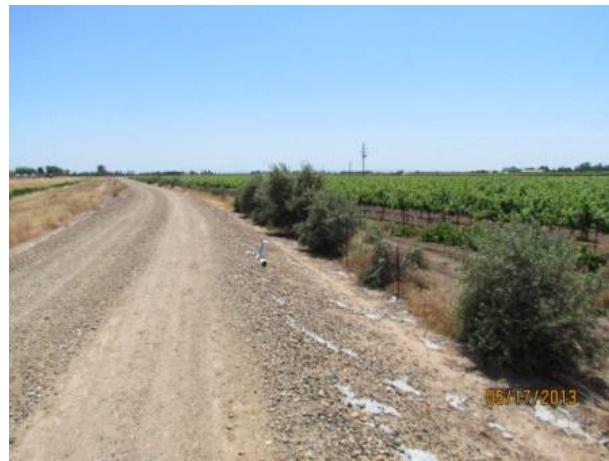
Levee Mile Report Line	3
Start Levee Mile	1.07
End Levee Mile	1.14
Location	Land Side
Category	Earthen Levee
Item	Encroachments
View of the ditch on the landside of the levee looking upstream. The picture was taken during fall 2011 inspection.	pkazi_f_20131001_220.jpg

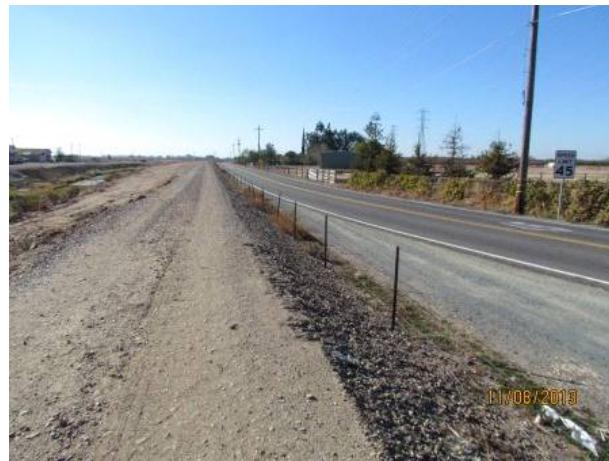
Levee Mile Report Line	5
Start Levee Mile	2.25
End Levee Mile	2.42
Location	Land Side
Category	Earthen Levee
Item	Encroachments
A fence was found on the landside toe of the levee looking downstream.	
pkazi_f_20131001_216.jpg

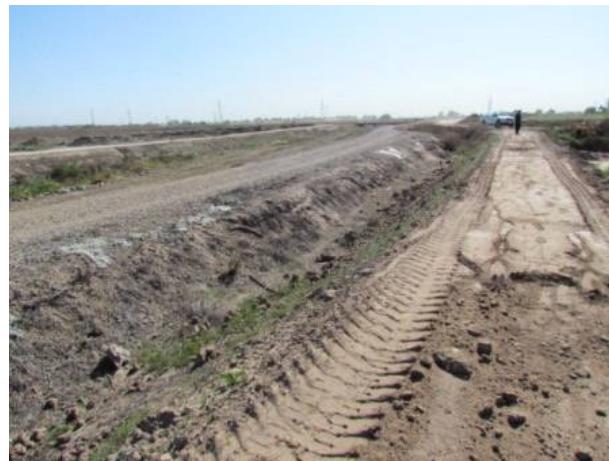
Levee Mile Report Line	8
Start Levee Mile	2.97
End Levee Mile	2.97
Location	Land Side
Category	Earthen Levee
Item	Encroachments
A detention pond was found next the landside toe of the levee. The pond had approximately depth of 15 feet. The picture was taken from the crown looking towards the toe of the levee.	
pkazi_f_20131001_219.jpg

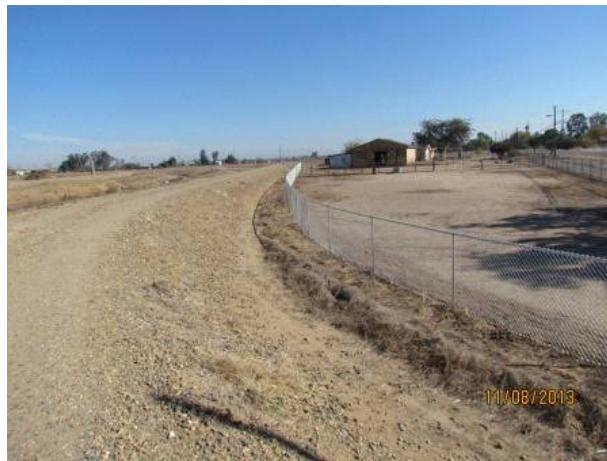
Levee Mile Report Line	3
Start Levee Mile	0.59
End Levee Mile	1.30
Location	Land Side
Category	Earthen Levee
Item	Encroachments
Fence was located on the landside toe of the levee looking upstream.	pkazi_f_20131001_224.jpg

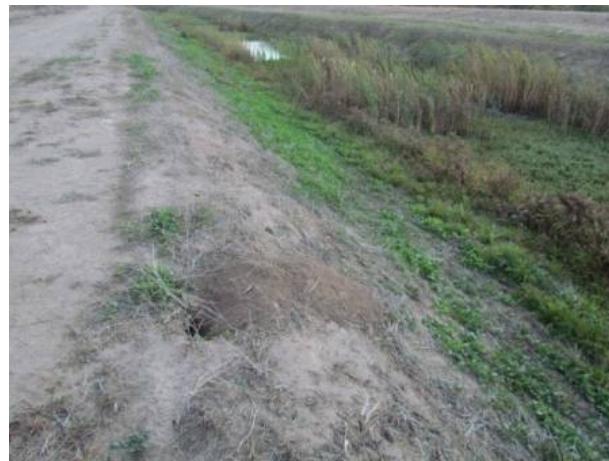
Levee Mile Report Line	8
Start Levee Mile	0.83
End Levee Mile	0.83
Location	Water Side
Category	Earthen Levee
Item	Animal Control
View of a large diameter rodent hole in the waterward berm looking downstream.	
<i>pkazi_f_20131001_241.jpg</i>

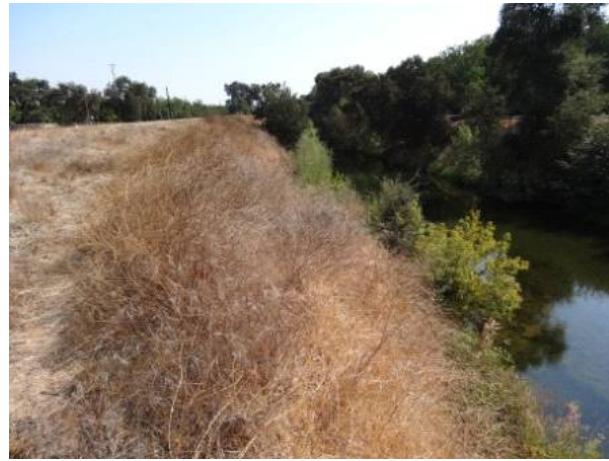
Levee Mile Report Line	5
Start Levee Mile	0.87
End Levee Mile	0.87
Location	Water Side
Category	Earthen Levee
Item	Slope Stability
Slope instability was found on the waterside slope of the levee looking downstream.	
pkazi_f_20131118_047.JPG

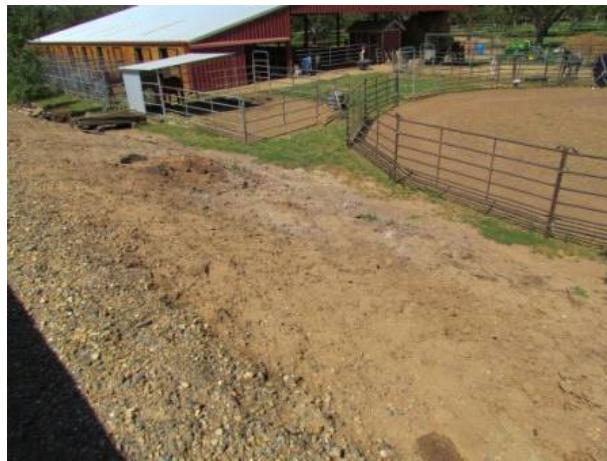
Levee Mile Report Line	16
Start Levee Mile	2.68
End Levee Mile	2.71
Location	Land Side
Category	Earthen Levee
Item	Encroachments
Recently built retaining wall at toe of landside levee at LM 2.68.	
pkazi_f_20131001_304.JPG

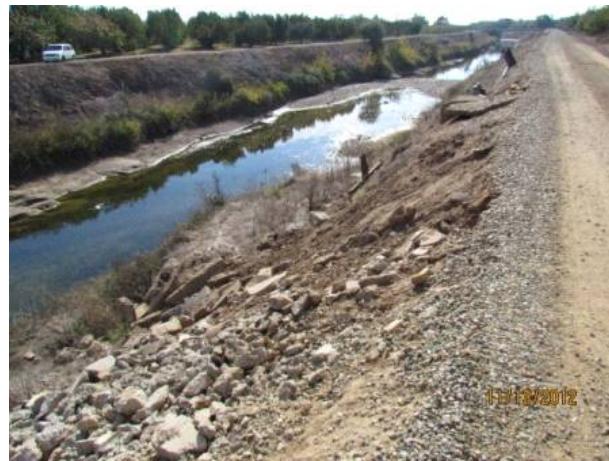
Levee Mile Report Line	29
Start Levee Mile	3.86
End Levee Mile	3.86
Location	Water Side
Category	Earthen Levee
Item	Slope Stability
Updated picture of the slope instability on the waterside slope of the levee looking downstream.	
pkazi_f_20131001_285.JPG

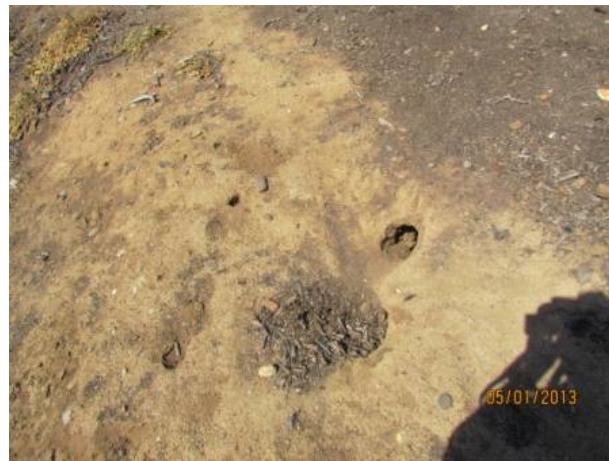
Levee Mile Report Line	56
Start Levee Mile	5.77
End Levee Mile	5.77
Location	Water Side
Category	Earthen Levee
Item	Animal Control
Updated picture of the animal holes on the waterside of the levee looking downstream.	
pkazi_f_20131119_054.JPG

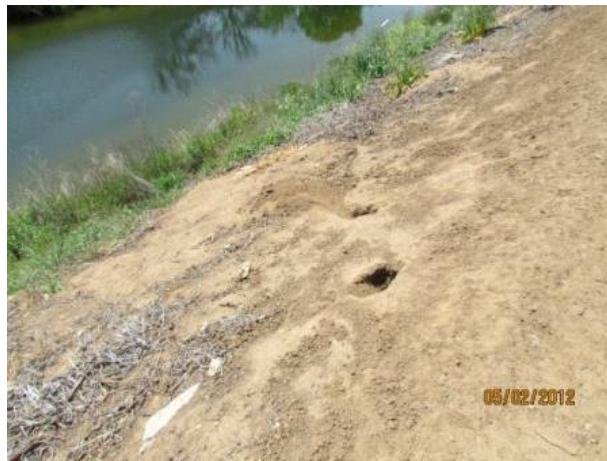
Levee Mile Report Line	66
Start Levee Mile	6.57
End Levee Mile	6.57
Location	Land Side
Category	Earthen Levee
Item	Animal Control
Rodent holes were found on the landside of the levee looking downstream.	
pkazi_f_20131119_056.JPG

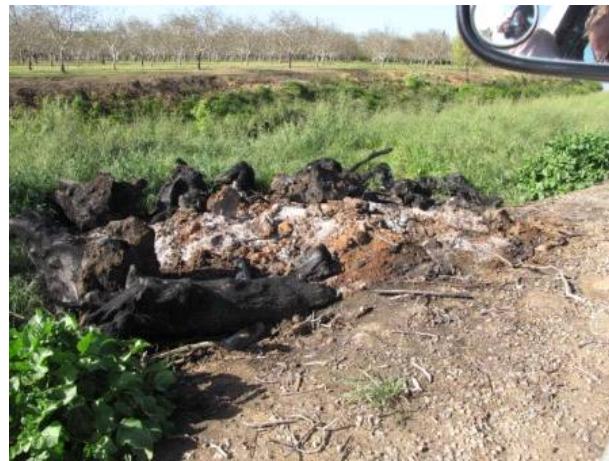
Levee Mile Report Line	101
Start Levee Mile	10.62
End Levee Mile	10.62
Location	Water Side
Category	Earthen Levee
Item	Encroachments
Prunings were found on the waterside of the levee looking downstream.	
pkazi_f_20131001_313.jpg

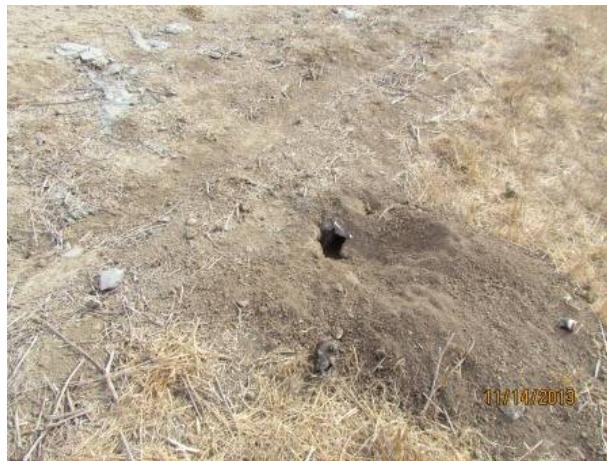
Levee Mile Report Line	121
Start Levee Mile	15.71
End Levee Mile	15.71
Location	Land Side
Category	Earthen Levee
Item	Animal Control
Animal holes were found on the landside slope of the levee looking downstream.	
pkazi_f_20131119_063.JPG

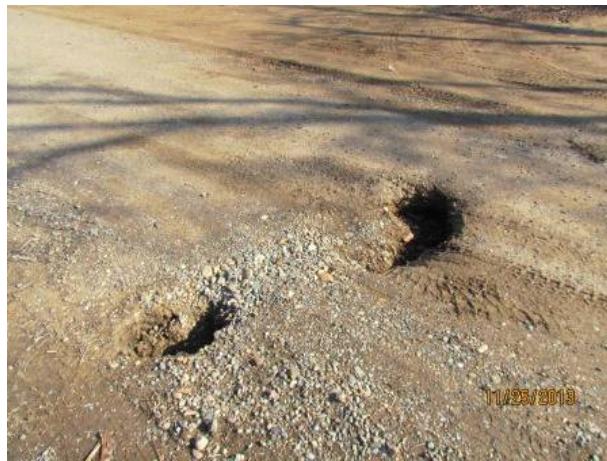
Levee Mile Report Line	32
Start Levee Mile	3.00
End Levee Mile	3.06
Location	Water Side
Category	Supplemental
Item	DWR Erosion Survey
Front view of erosion.	
SJR2013_NA0017U16RM20_2.jpg

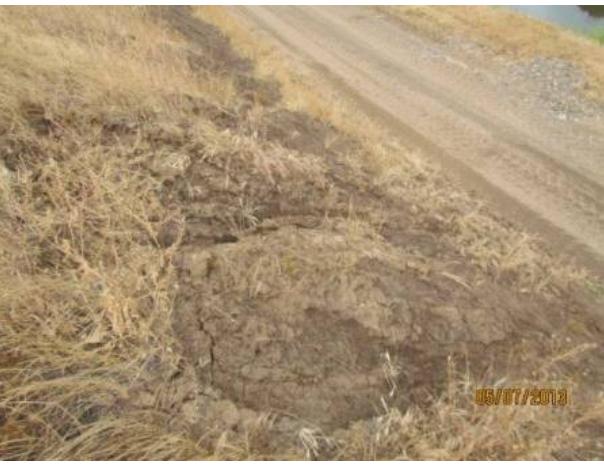
pkazi\_f\_20131001\_467.JPG

Slope instability was found on the waterside slope of the levee looking downstream.

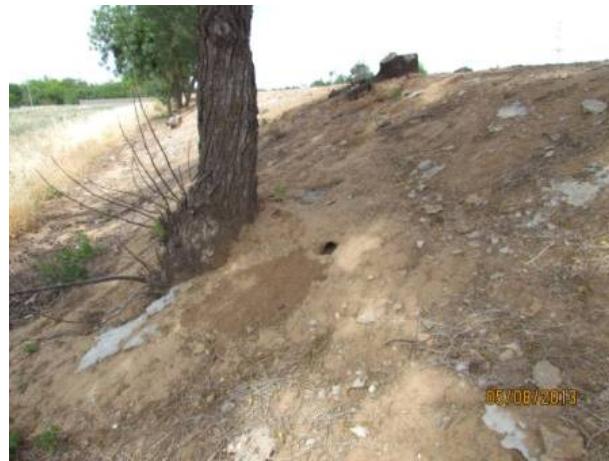
Levee Mile Report Line	130
Start Levee Mile	19.41
End Levee Mile	19.41
Location	Land Side
Category	Earthen Levee
Item	Animal Control
An animal hole was found on the landside of the levee looking towards the crown.	
pkazi_f_20131001_491.JPG

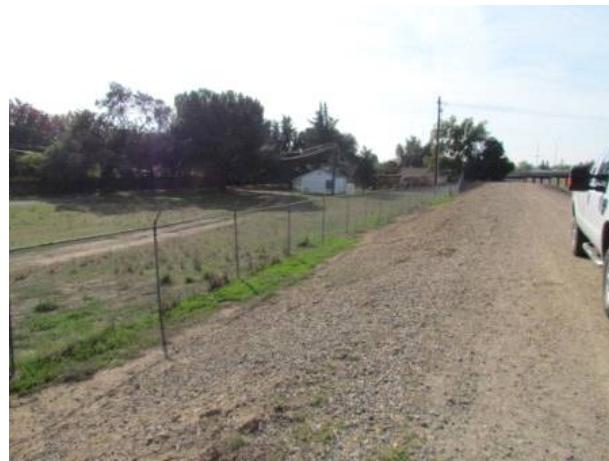
Levee Mile Report Line	140
Start Levee Mile	20.04
End Levee Mile	20.04
Location	Land Side
Category	Earthen Levee
Item	Encroachments
Fences were obstructing the landside slope of the levee looking downstream.	
<i>pkazi_f_20131001_436.JPG</i>
